Subject: Request for Expedited Project Review – Project Number 743764
FEMA-4699-DR-CA, 2023 February-April Storms
Cal OES ID: 063-58352 FEMA ID: 063-58352-00
Subrecipient: City of Portola
Cal OES Log: COR-005713 FEMA Log: None

DR-4699-CA Influence on Bridge Condition

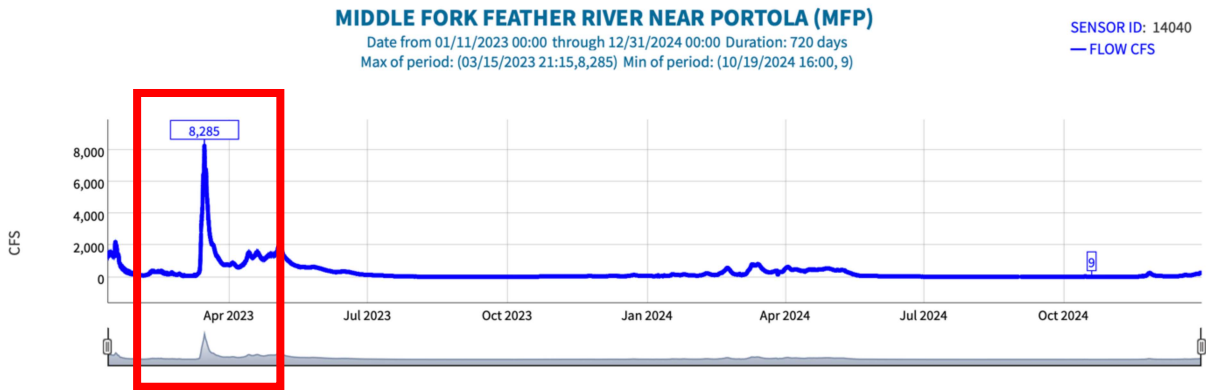
March 2023 Peak Flow

MIDDLE FORK FEATHER RIVER NEAR PORTOLA (MFP)

Date from 01/10/2022 00:00 through 12/31/2023 00:00 Duration: 720 days
Max of period: (03/15/2023 21:15,8,285) Min of period: (08/13/2022 15:30, 7)

SENSOR ID: 14040
— FLOW CFS: 170
DATETIME:
2022/03/29 14:15

As an additional point of analysis and evidence to the impact of the DR-4699-CA disaster on the bridge, the City has reviewed the MIDDLE FORK FEATHER RIVER NEAR PORTOLA (MFP) historical flow data provided by the California Department of Water Resources. The flow data referenced below indicates a **peak flow of 8,285 CFS during March of 2023**, which aligns with the incident period from DR-4699-CA. We have also provided historical data back to 2018 illustrating normal flows for the river.

While there have historically been instances of increased flow during the spring season, **none of the flow increases from 2018 to 2024 compare to the significant spike experienced in March 2023, which was caused by the winter storm disaster.**

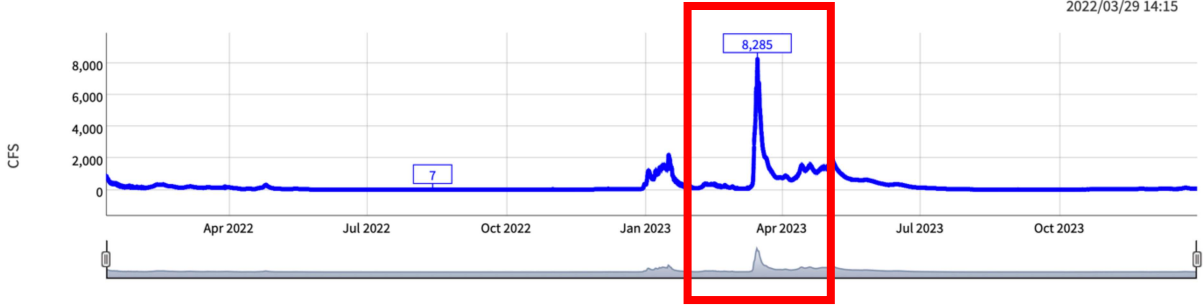
Historical Flow

MIDDLE FORK FEATHER RIVER NEAR PORTOLA (MFP)

Date from 01/10/2021 00:00 through 12/31/2022 00:00 Duration: 720 days
Max of period: (01/09/2022 12:45,903) Min of period: (07/11/2021 15:00, 7)

SENSOR ID: 14040
— FLOW CFS

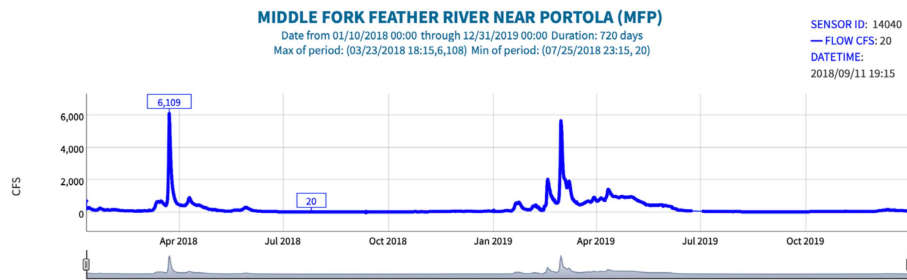
Plot from ending date: 12/31/2019 Span: 720 days
